Lower Passaic River Restoration Project

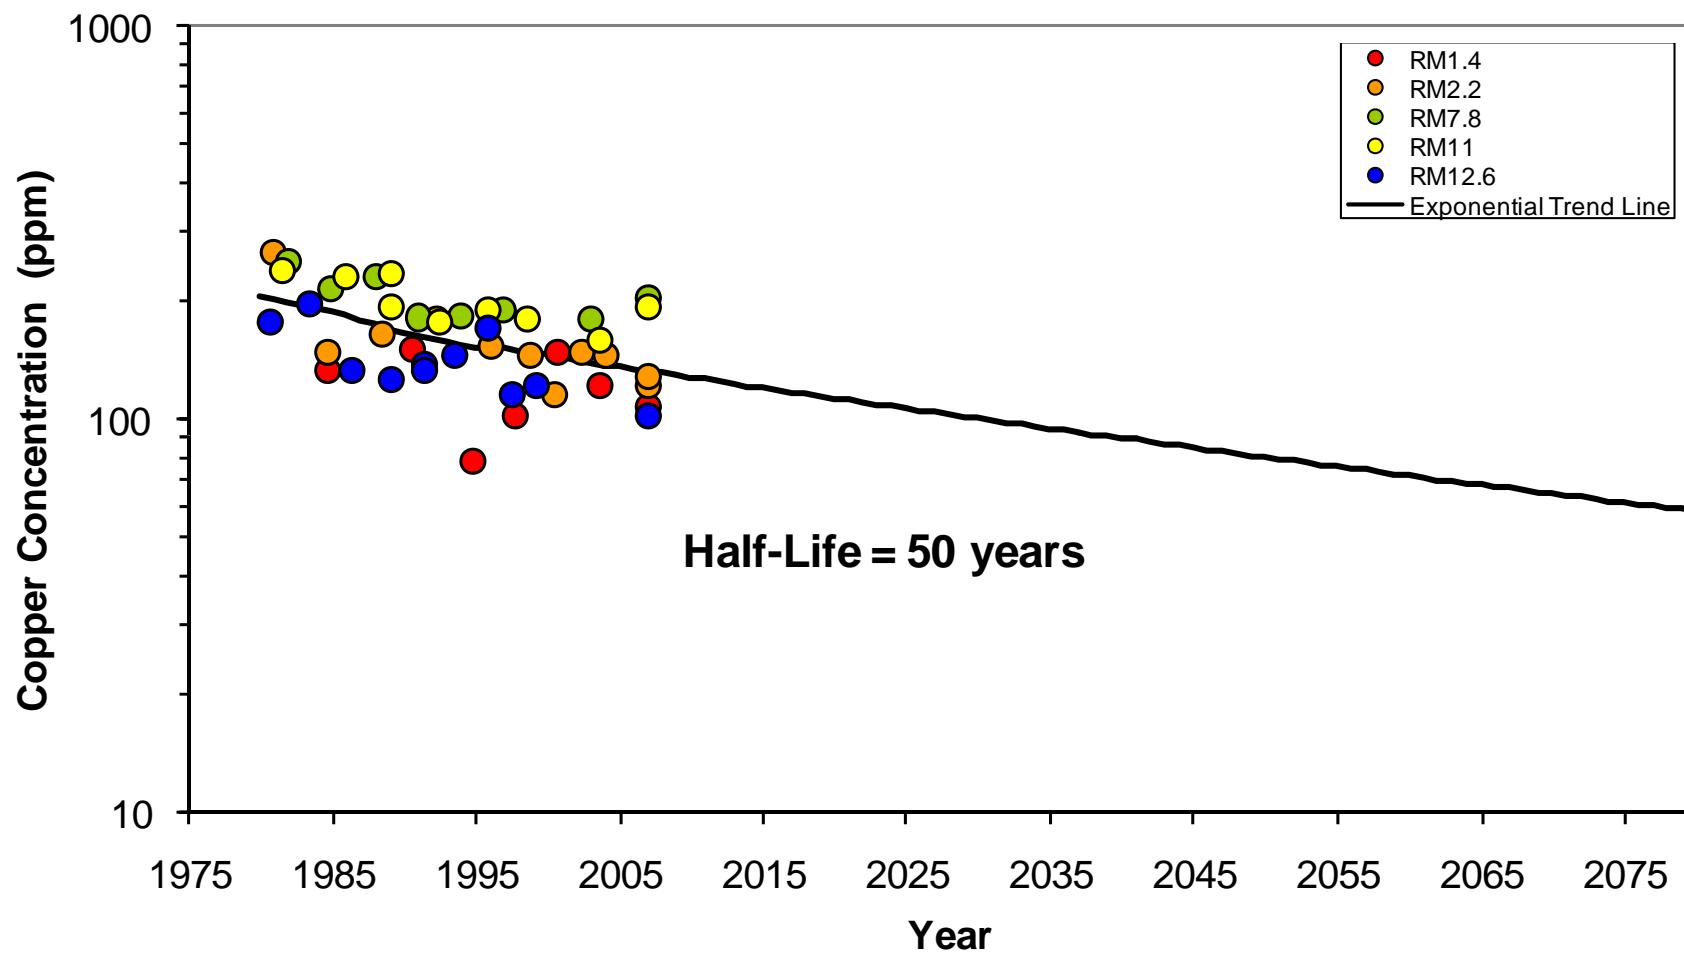
Figure 20-13

High-Resolution Core Results for Copper

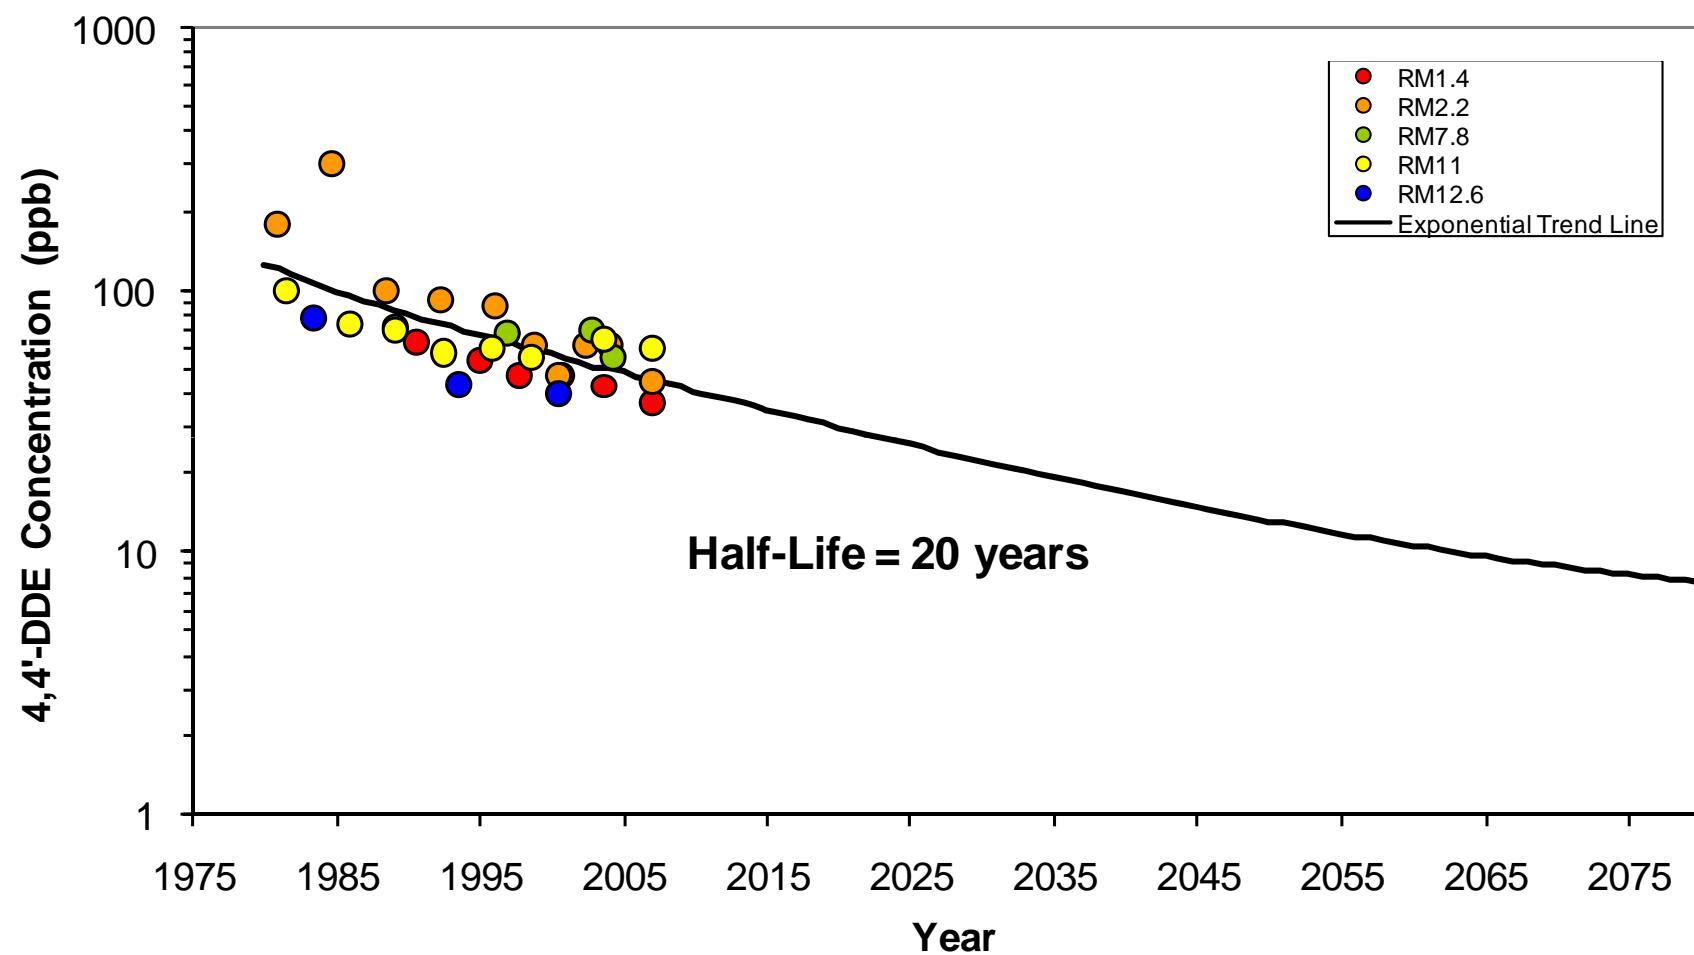
Figure 20-14

High-Resolution Core Results for 4,4'-DDE

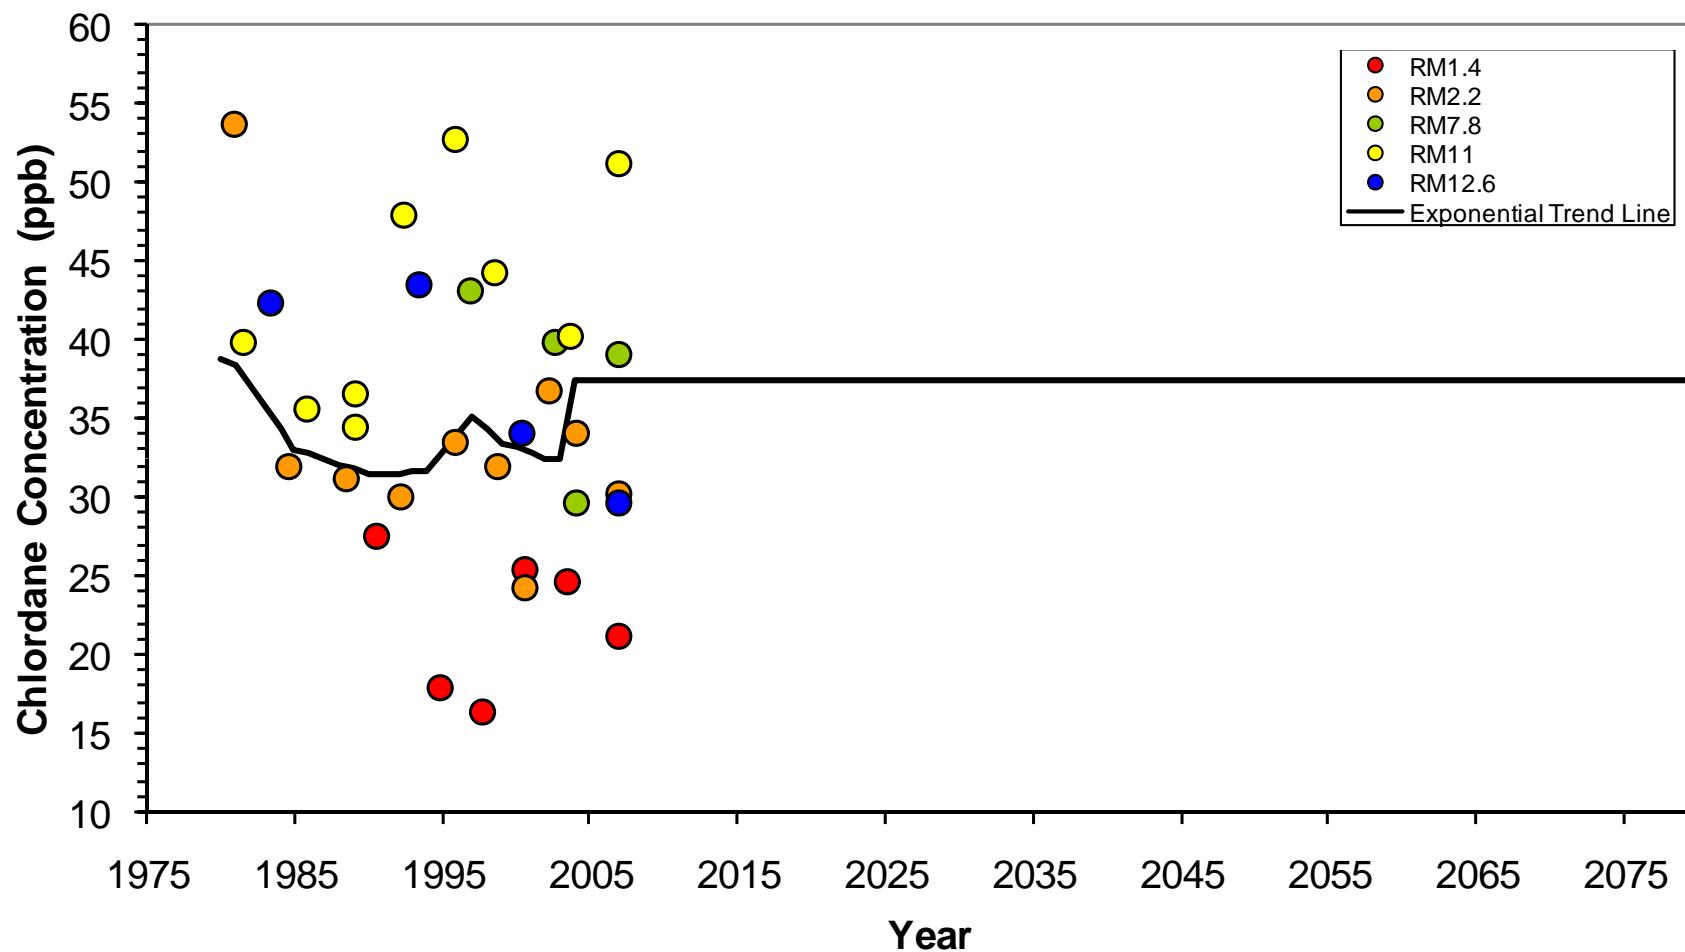
Figure 20-15

High-Resolution Core Results for Chlordane

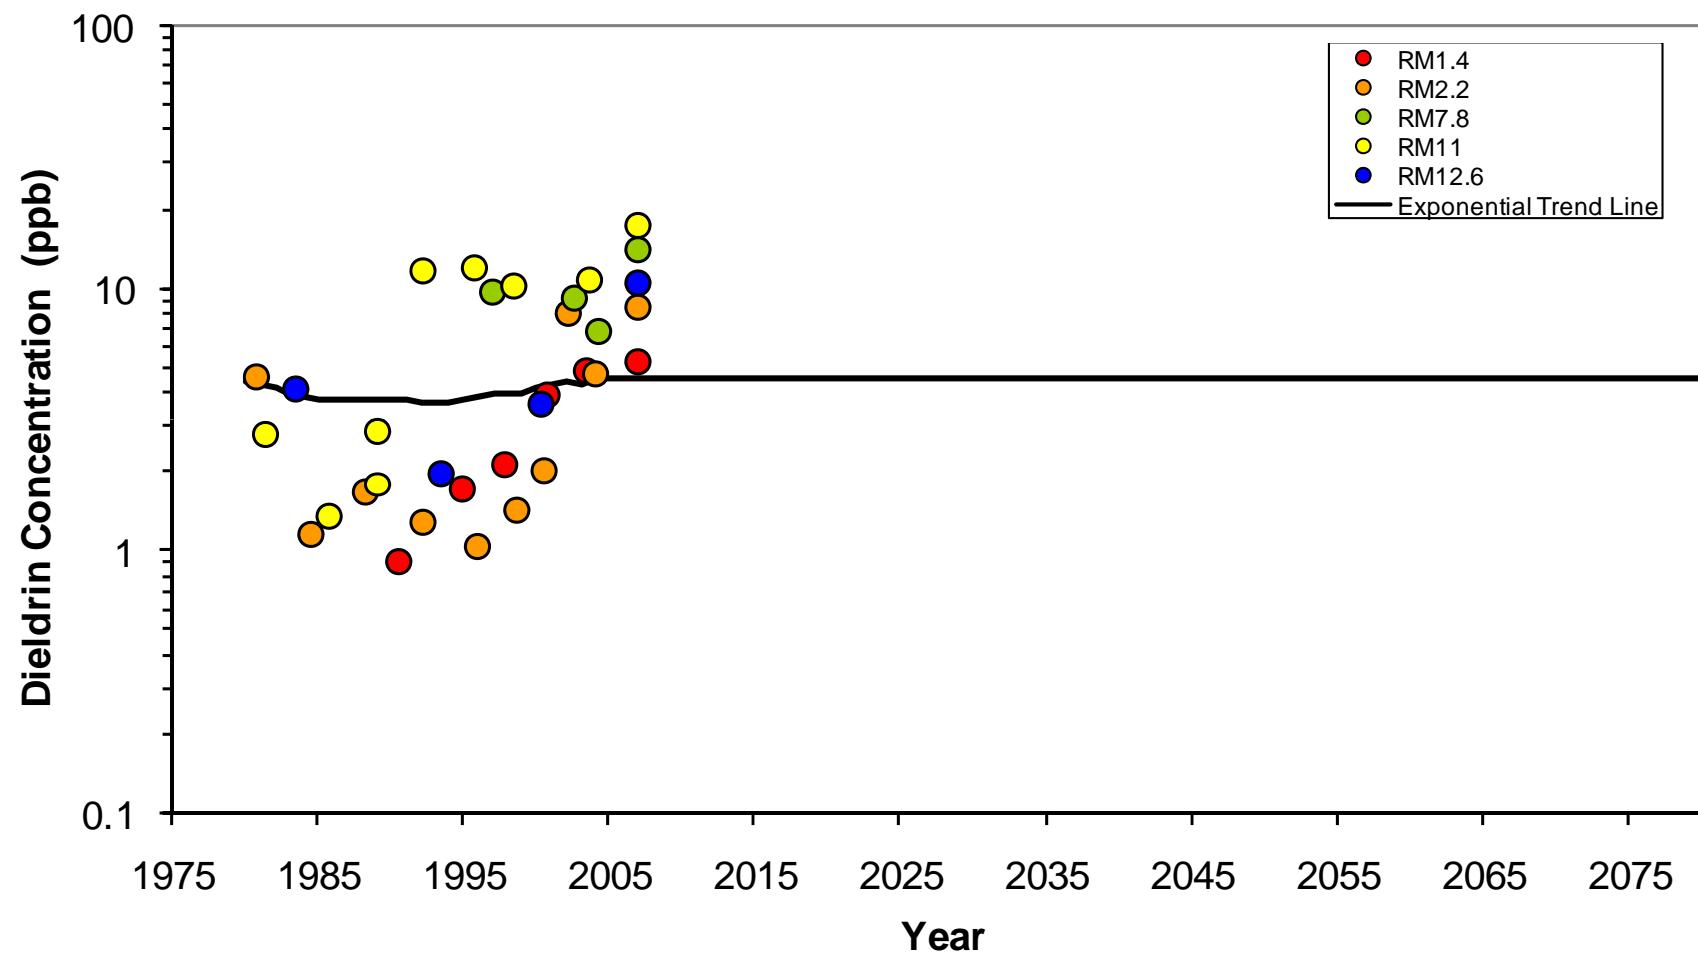
Figure 20-16

High-Resolution Core Results for Dieldrin

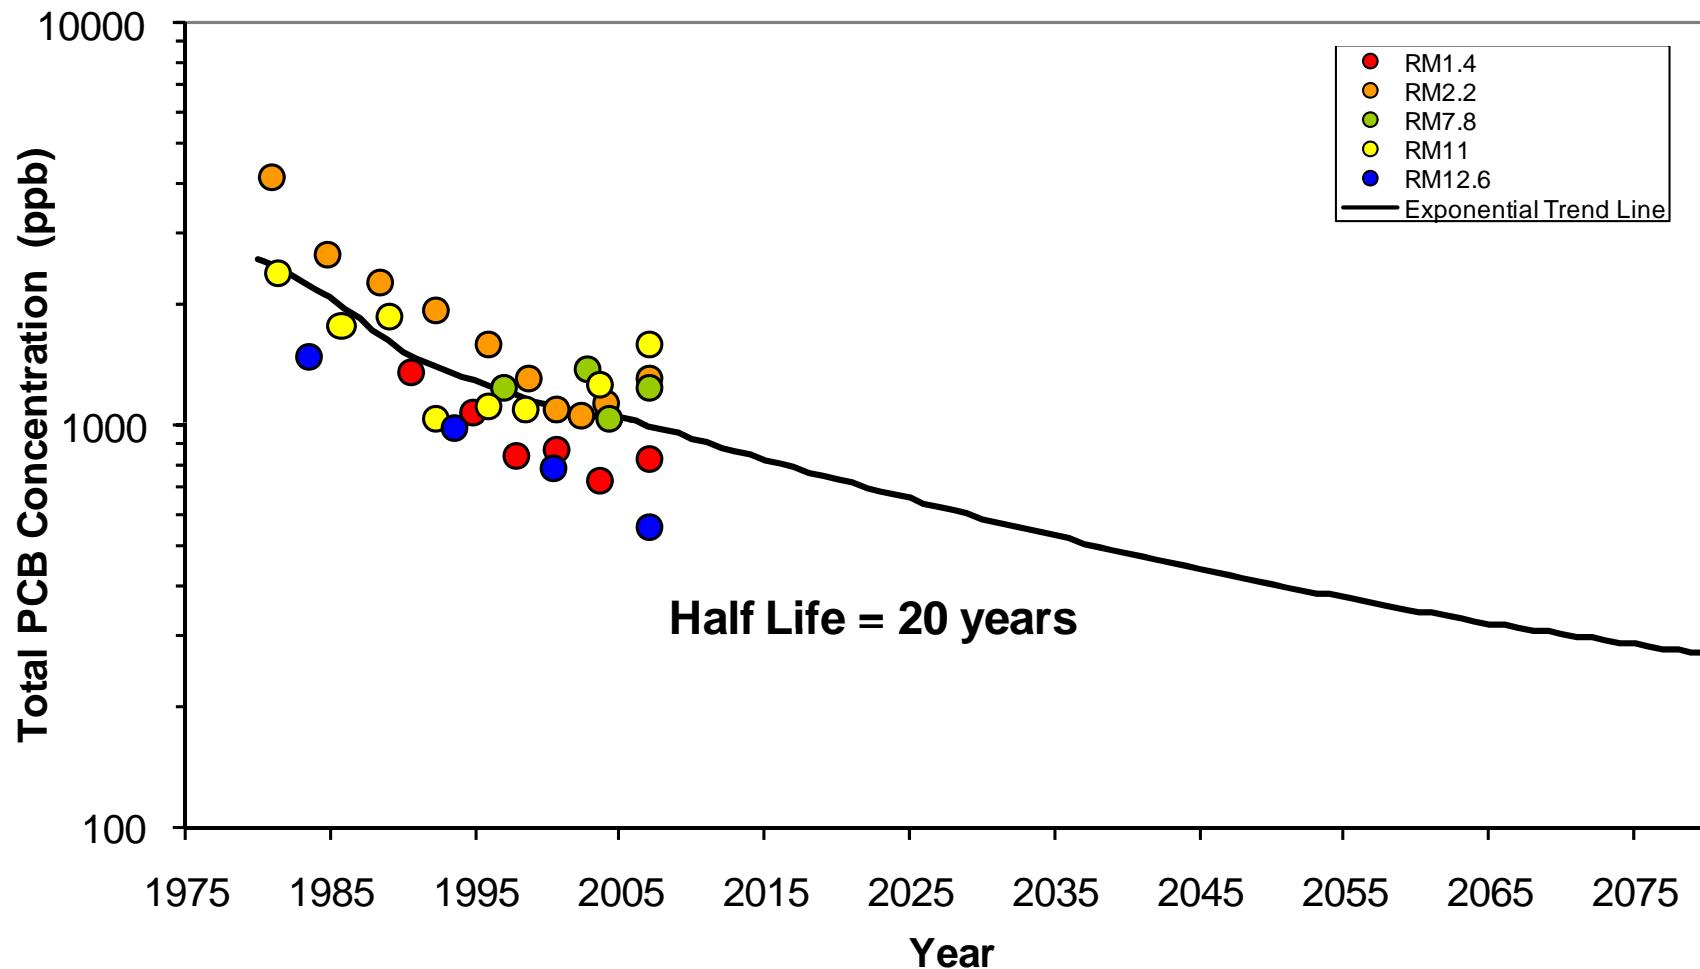
Figure 20-17

High-Resolution Core Results for Total PCB

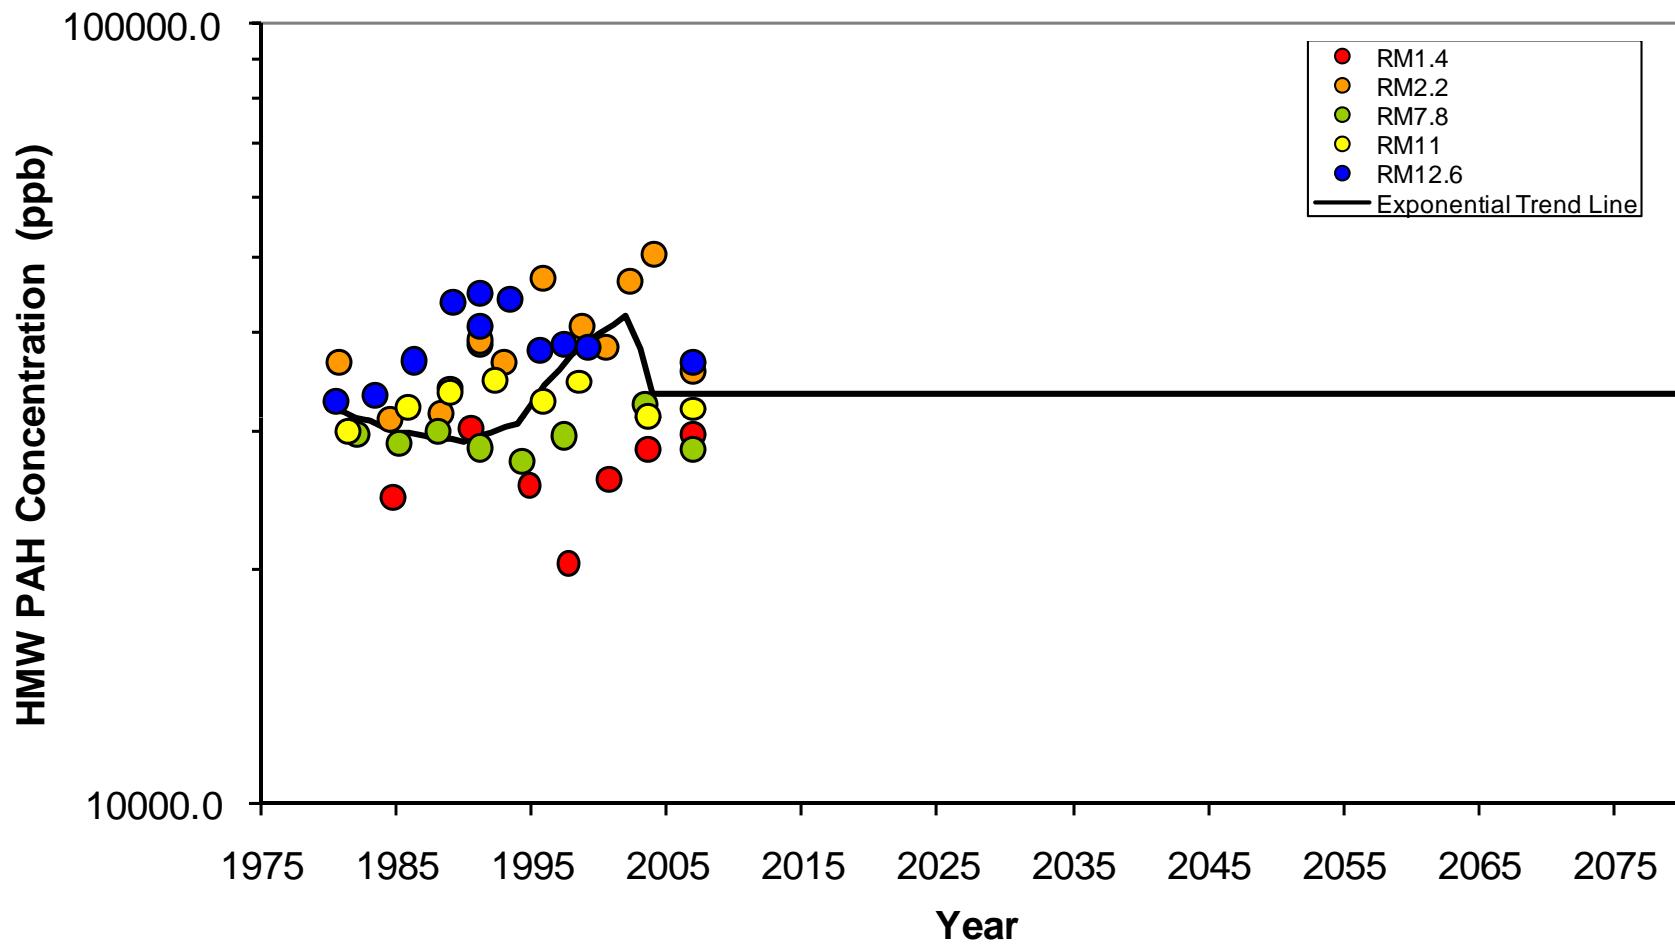
Figure 20-18

High-Resolution Core Results for HMW PAH

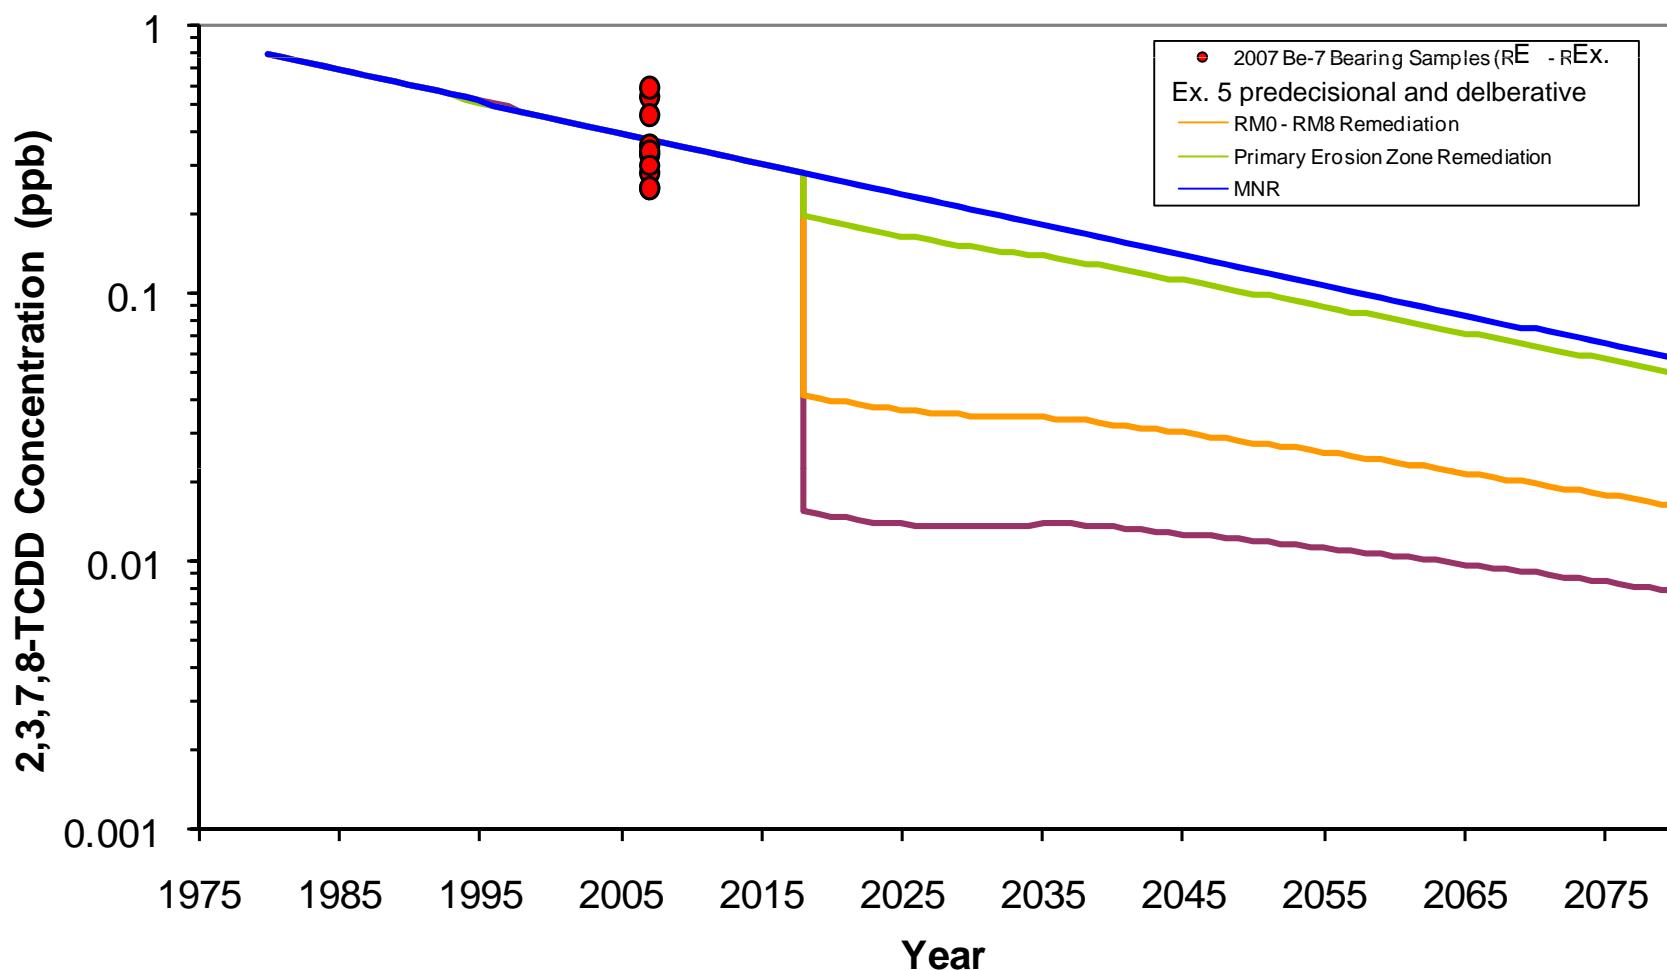
Figure 20-19

2,3,7,8-TCDD
Comparison of Estimated Trajectories for Remediation Options for Be-7
Bearing Sediment (Ex. 5)
Lower Passaic River Restoration Project

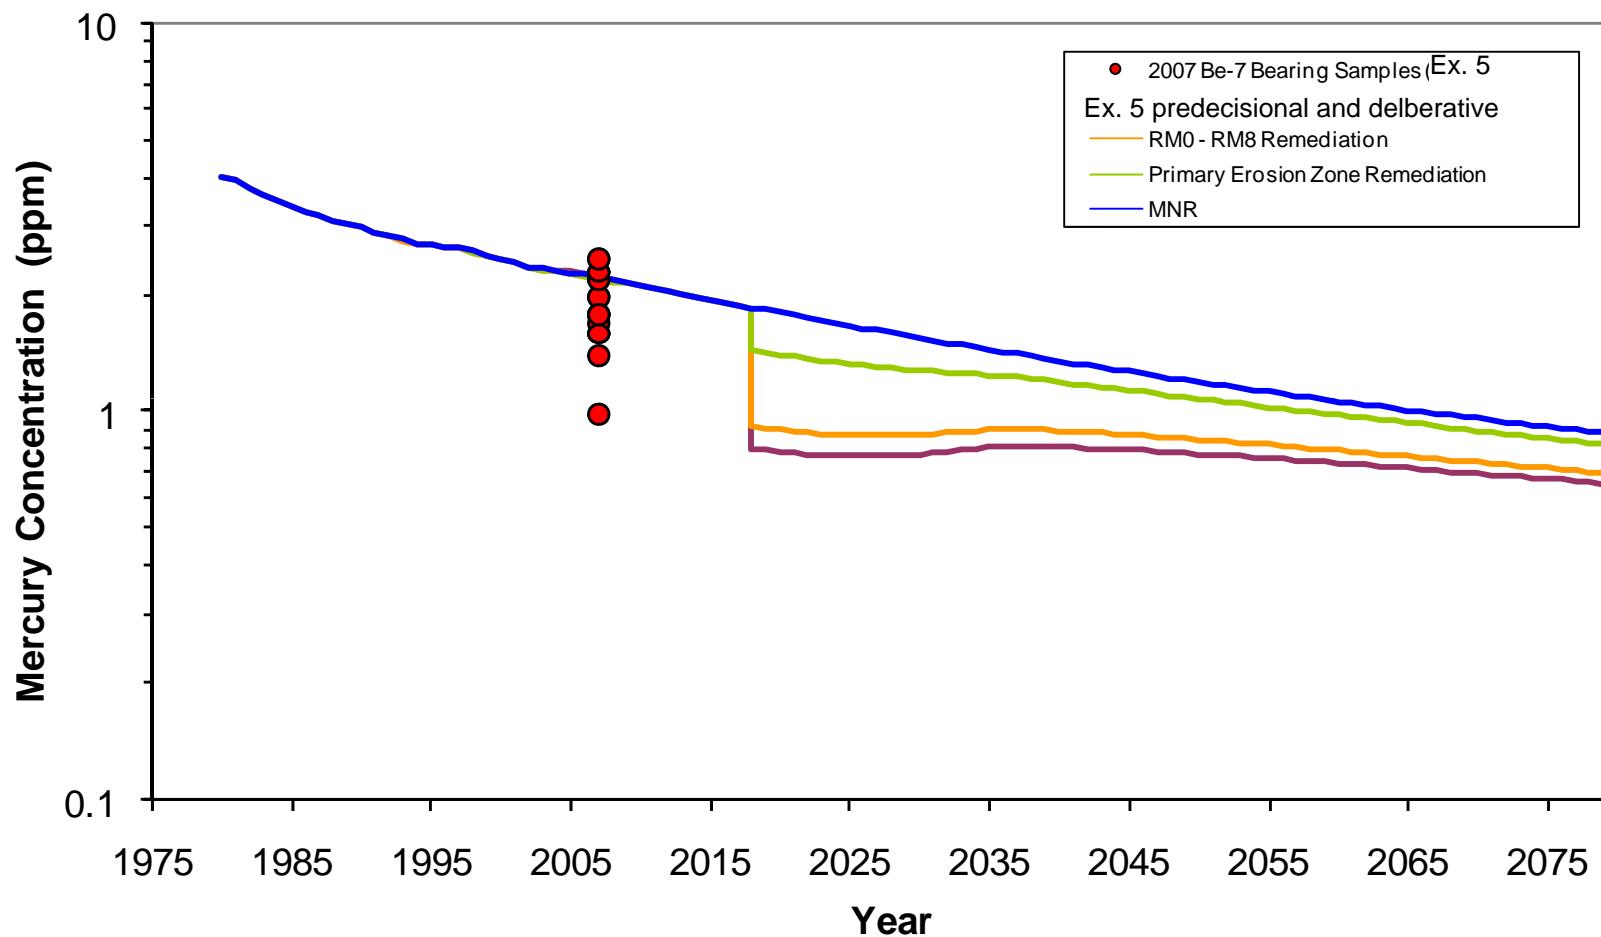
Figure 20-20

Mercury
Comparison of Estimated Trajectories for Remediation Options for Be-7
Bearing Sediment (Ex. 5)
Lower Passaic River Restoration Project

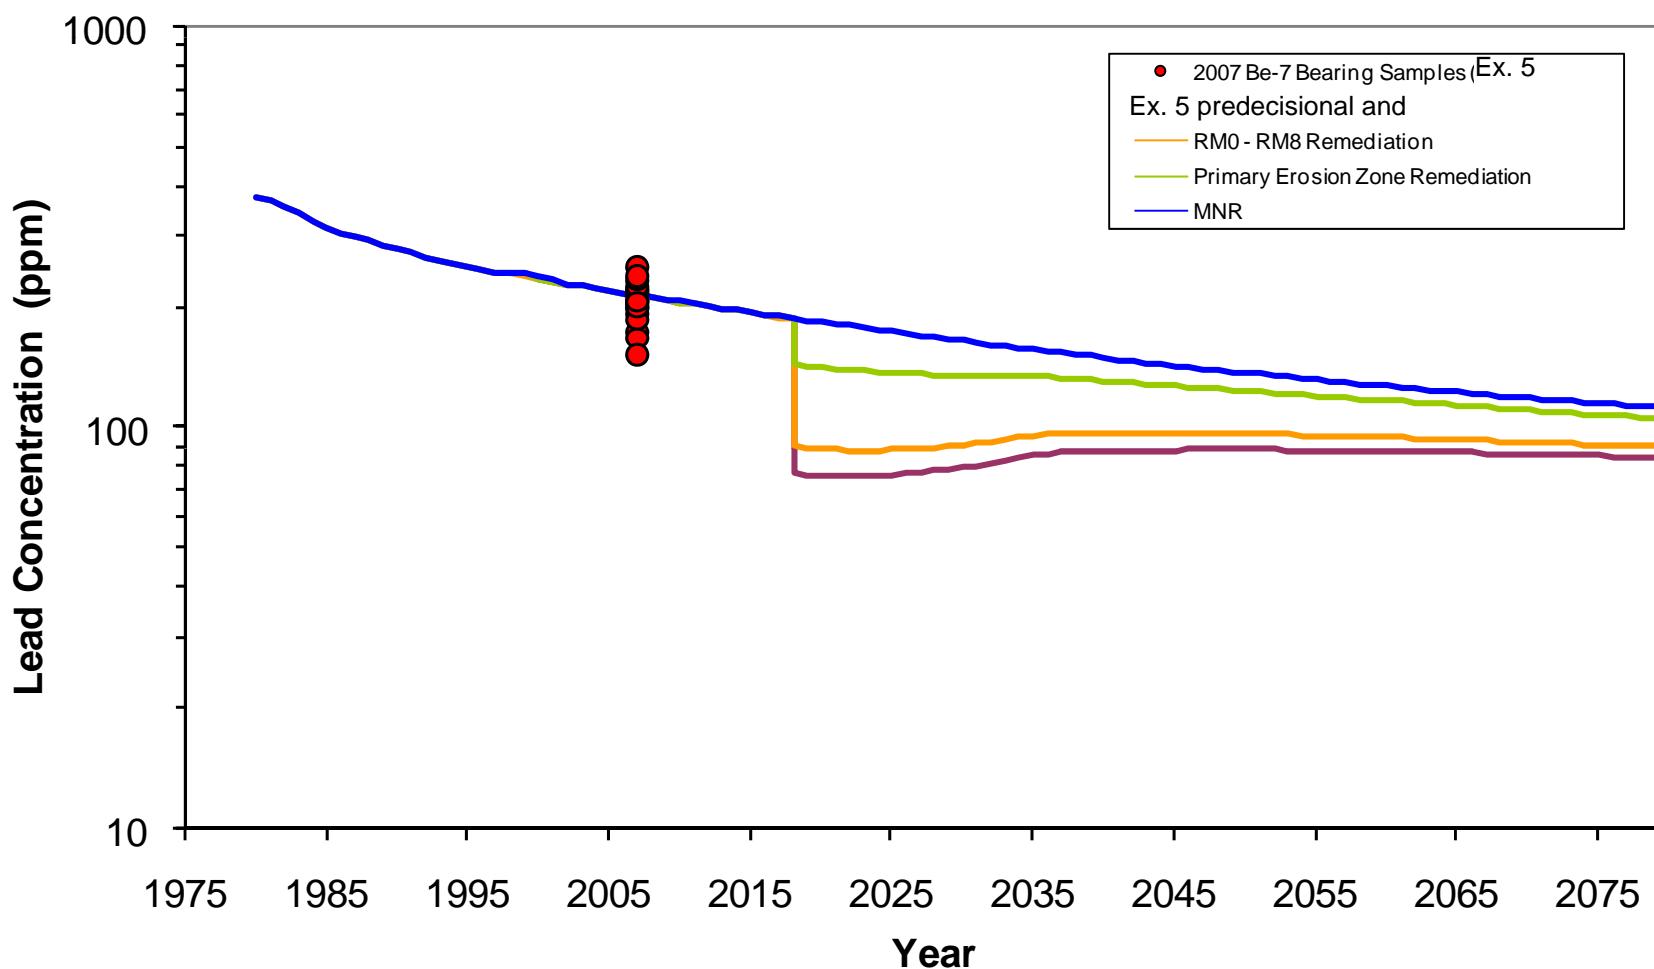
Figure 20-21

Lead
Comparison of Estimated Trajectories for Remediation Options for Be-7
Bearing Sediment (Ex. 5)
Lower Passaic River Restoration Project

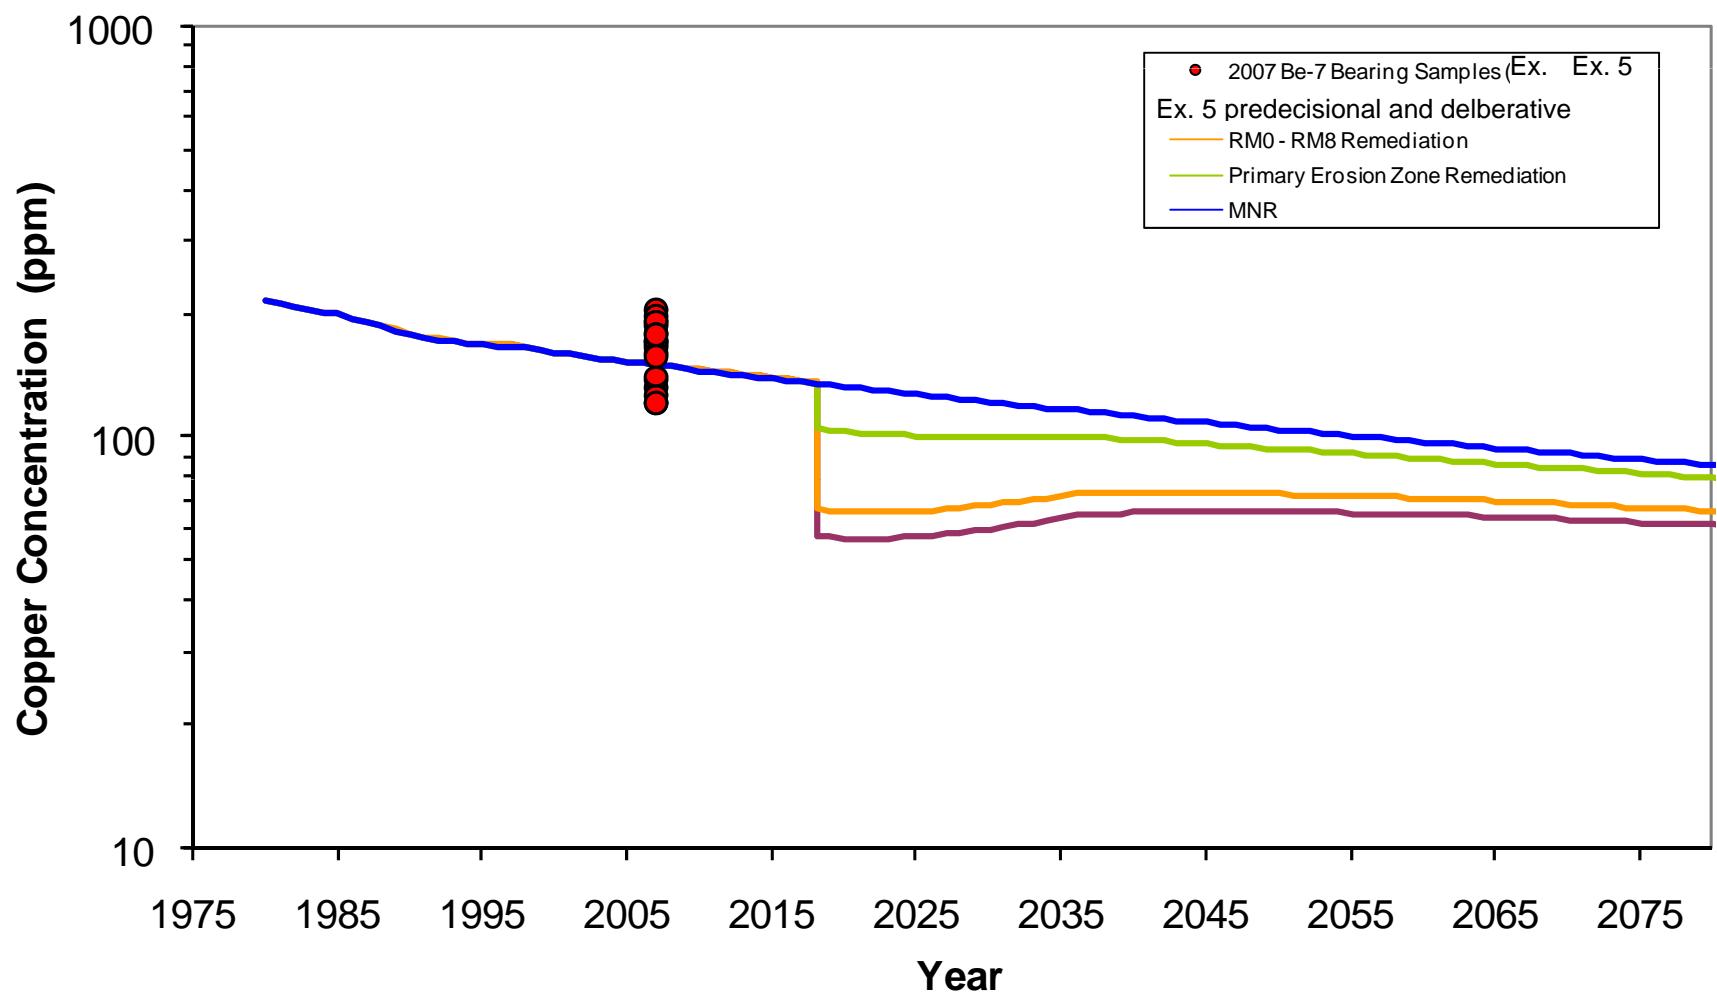
Figure 20-22

Copper
Comparison of Estimated Trajectories for Remediation Options for Be-7
Bearing Sediment (Ex. 5)
Lower Passaic River Restoration Project

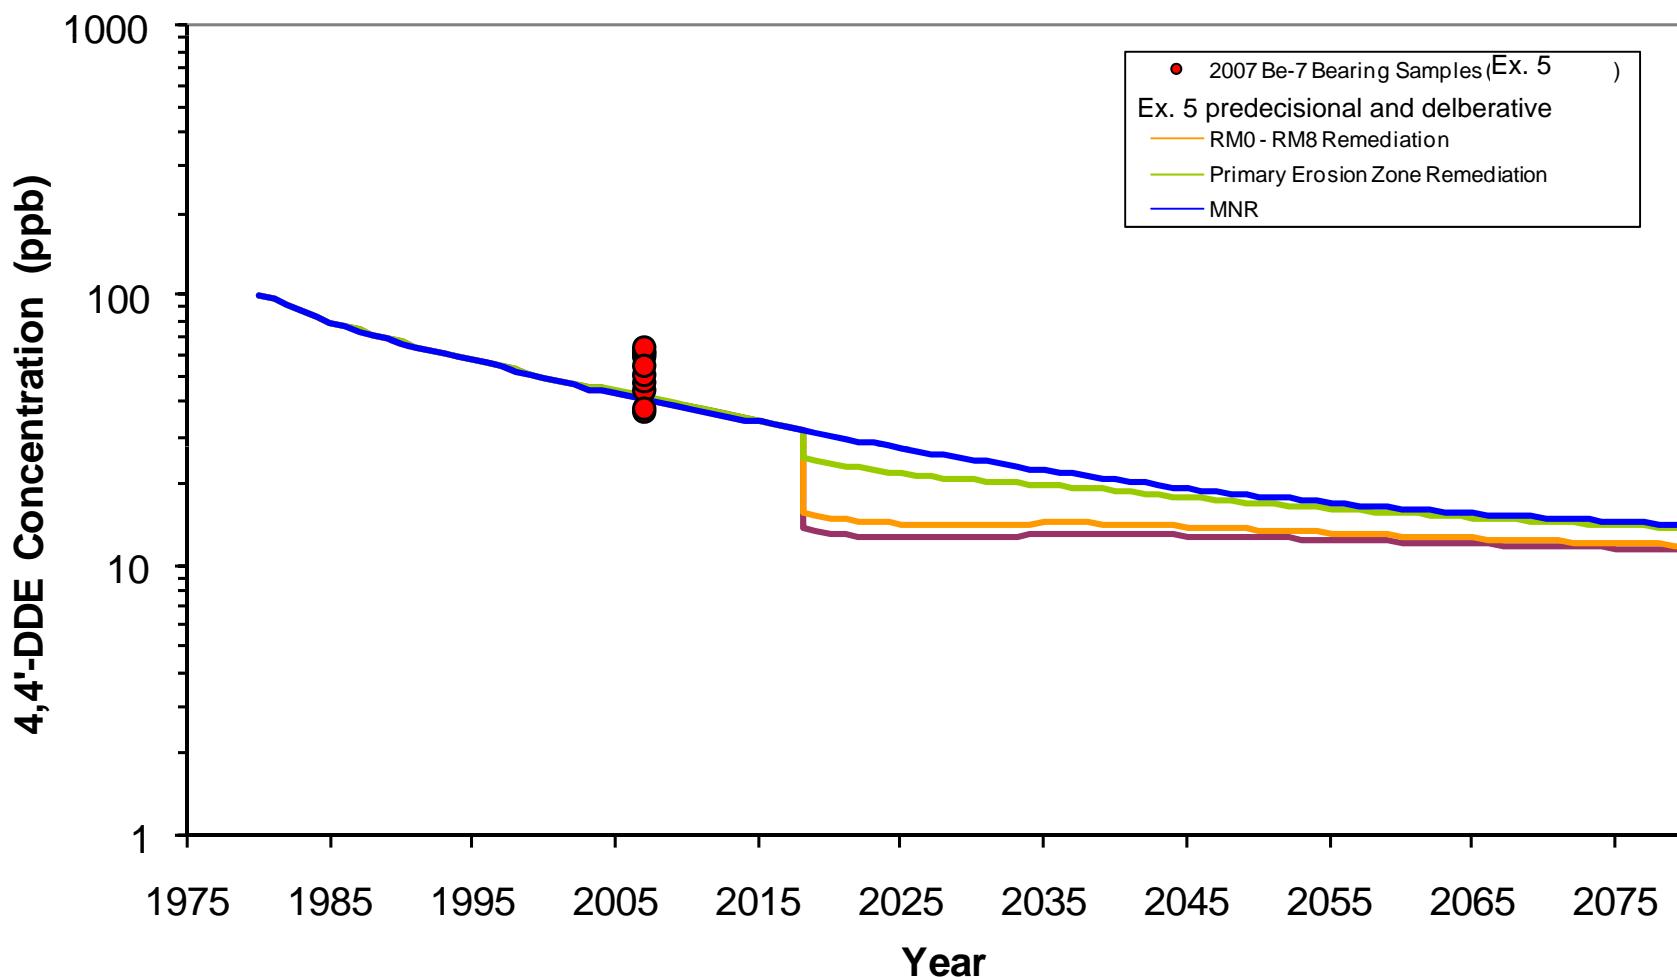
Figure 20-23

4,4'-DDE
Comparison of Estimated Trajectories for Remediation Options for Be-7
Bearing Sediment (Ex. 5)
Lower Passaic River Restoration Project

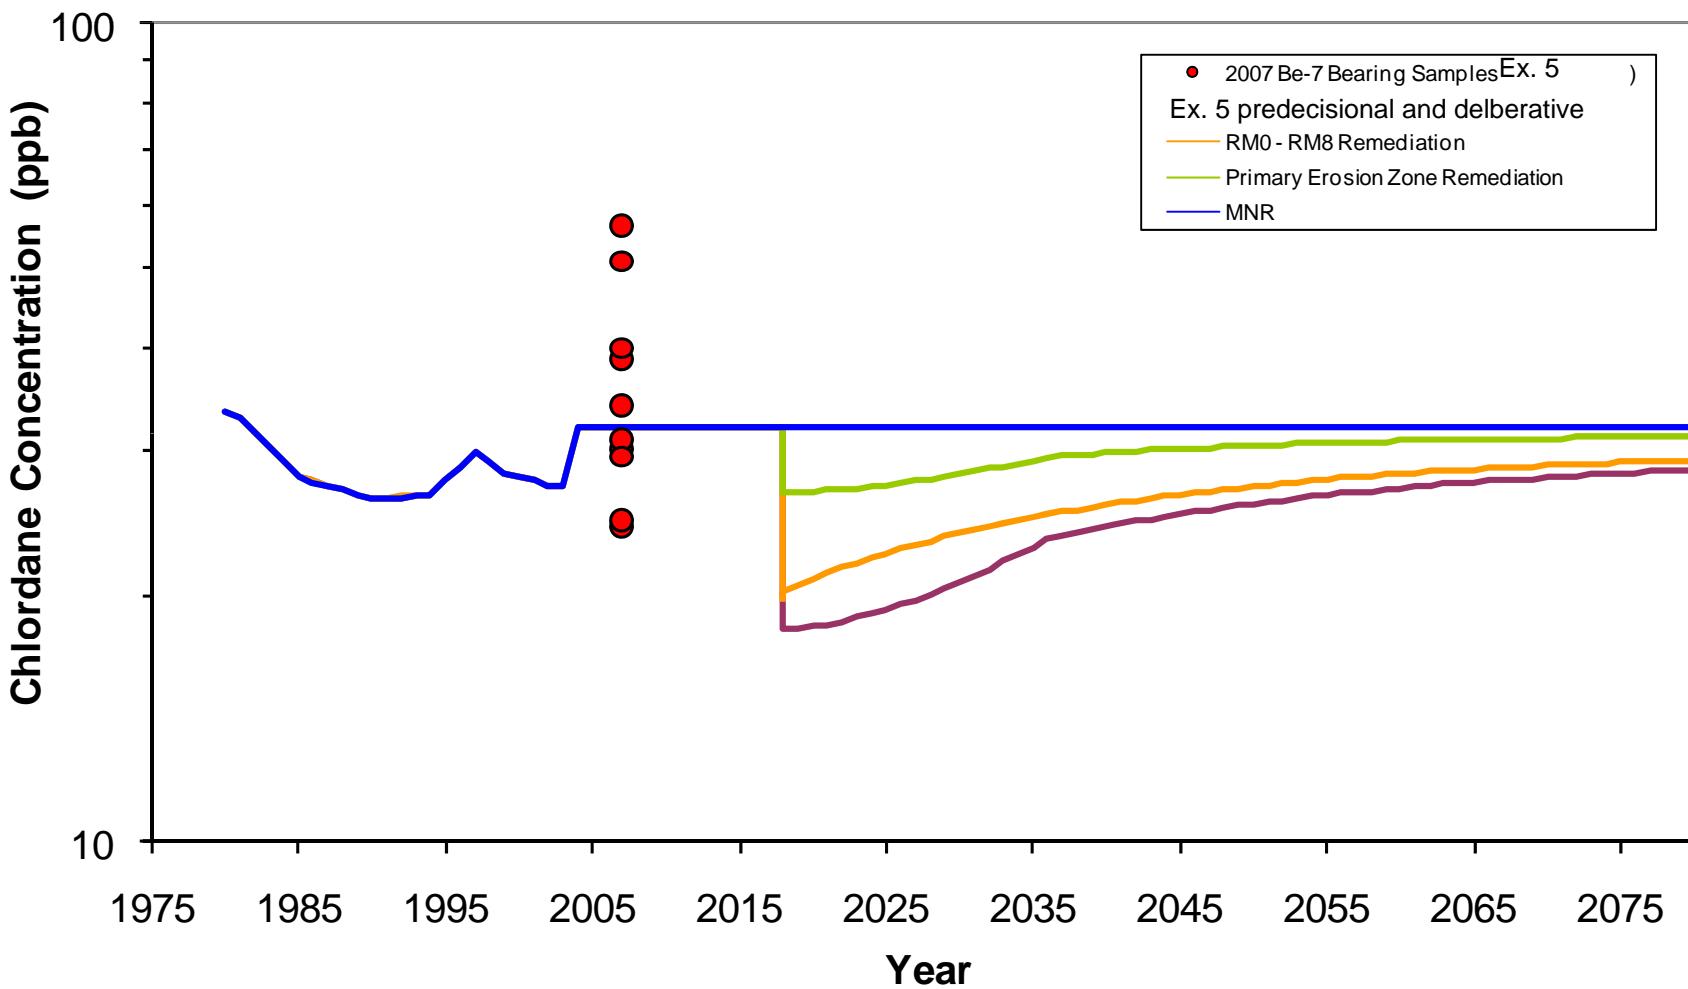
Figure 20-24

Chlordane
Comparison of Estimated Trajectories for Remediation Options for Be-7
Bearing Sediment (Ex. 5)
Lower Passaic River Restoration Project

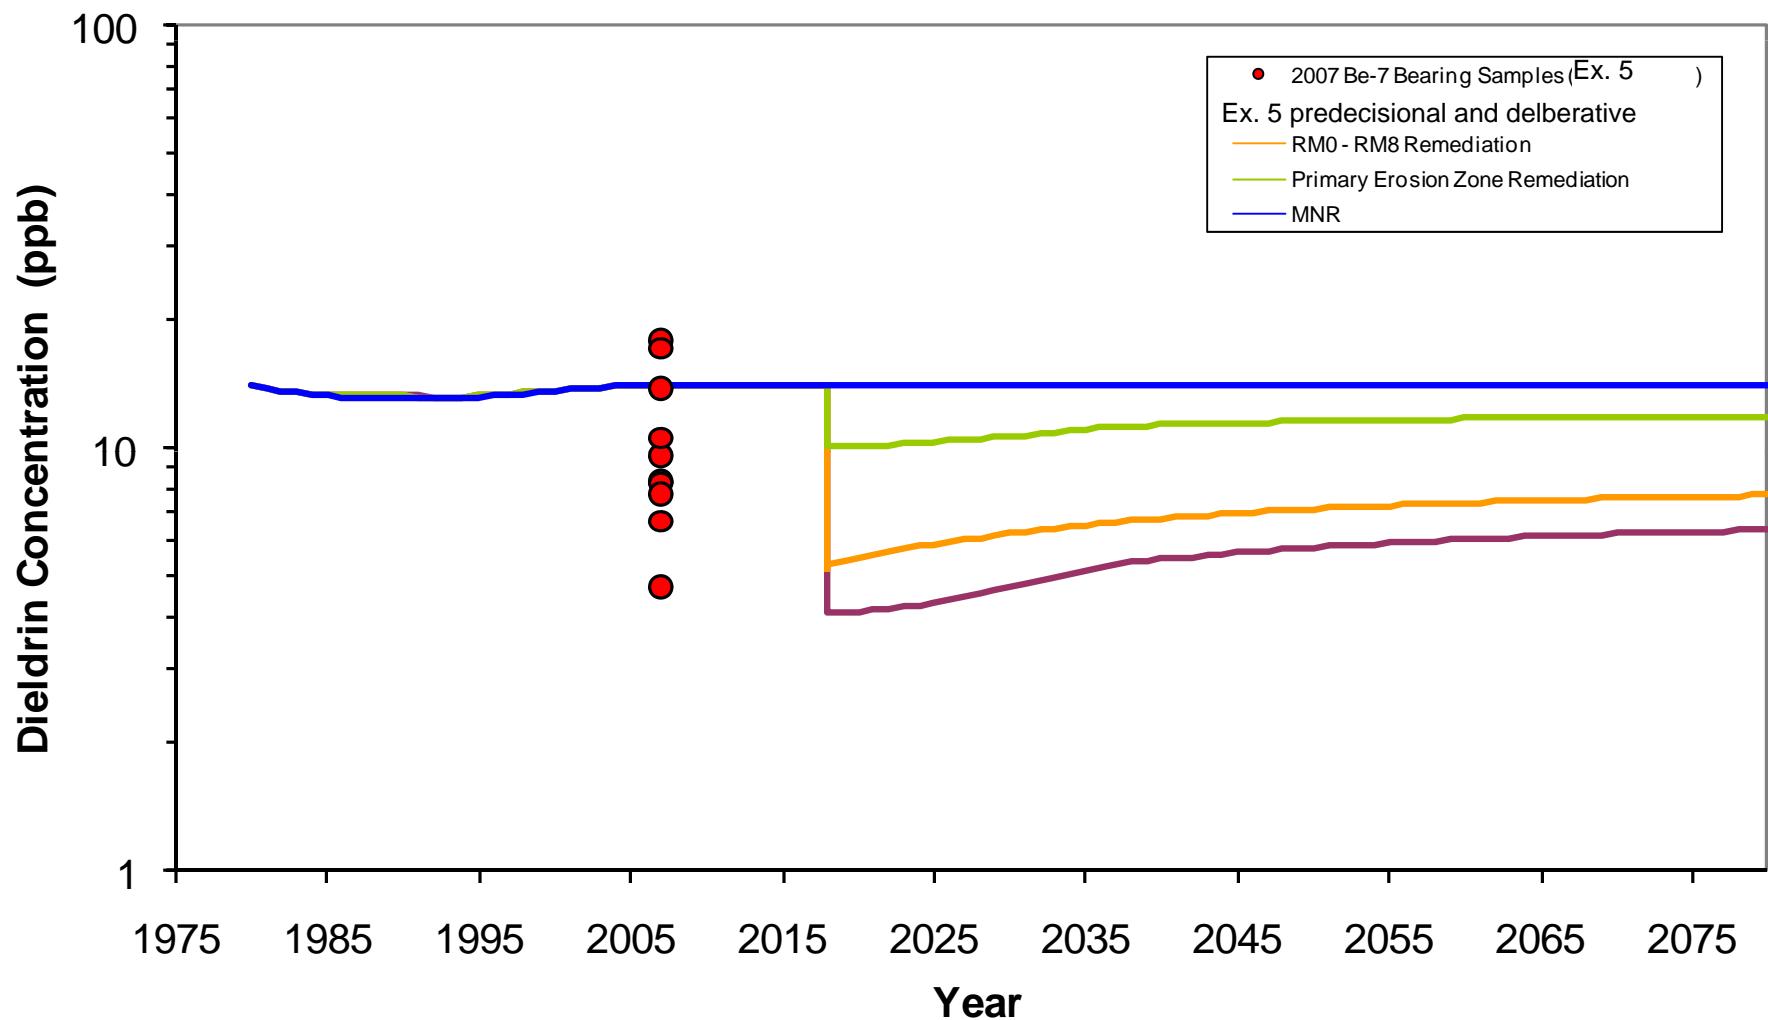
Figure 20-25

Dieldrin
Comparison of Estimated Trajectories for Remediation Options for Be-7
Bearing Sediment Ex. 5
Lower Passaic River Restoration Project

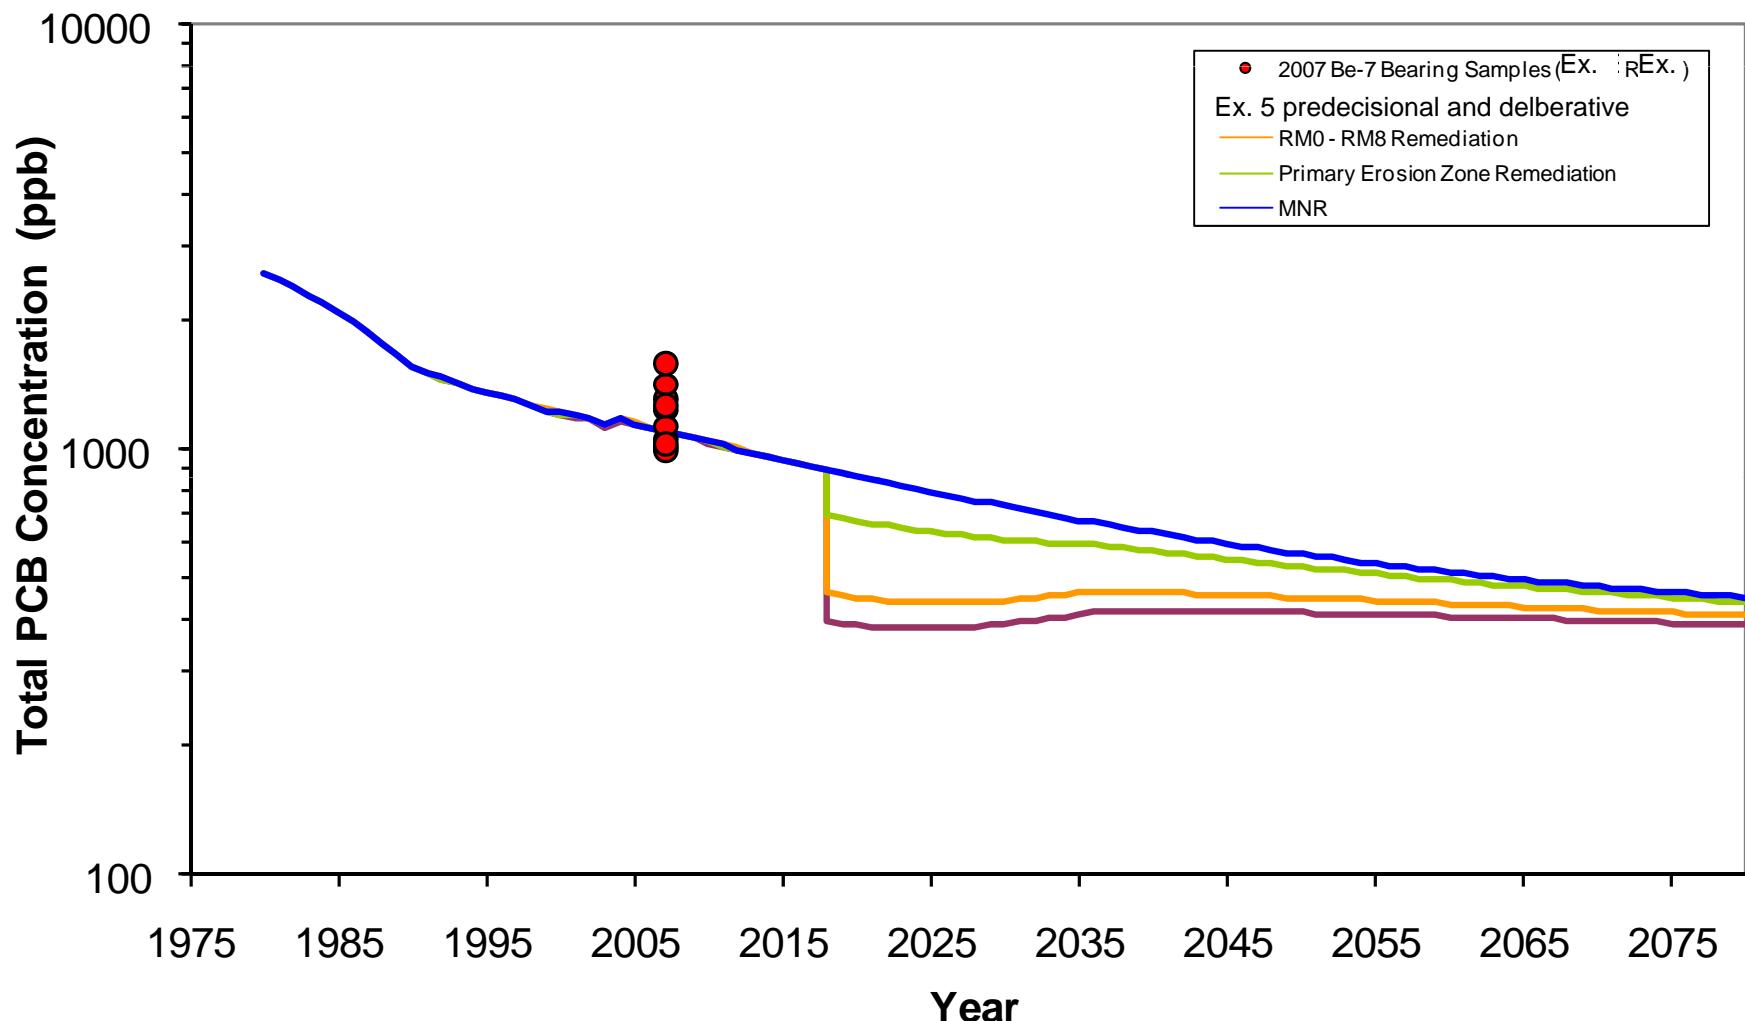
Figure 20-26

Total PCB
Comparison of Estimated Trajectories for Remediation Options for Be-7
Bearing Sediment (Ex. 5)
Lower Passaic River Restoration Project
